**Flood Control Project Maintenance  
Levee Inspections**  
**LMA District Cover Sheet**  
**Spring 2020 Levee Inspection Results**

**American River Flood Control District**

**Spring 2020 Levee Inspection Results**

Waterway			Bank	Unit Miles
Unit No. 01 Arcade Creek			Left	2.08
	Spring (March - May)	Summer (June - August)	(September - November) Fall	Winter (December - February)
Unit Maintenance Rating (Fall Only)				
Date of Inspection	3/25/2020 - 3/25/2020			
DWR Inspector	Luz Dial			
Accompanied By	Gilbert Gutierrez ARFCD

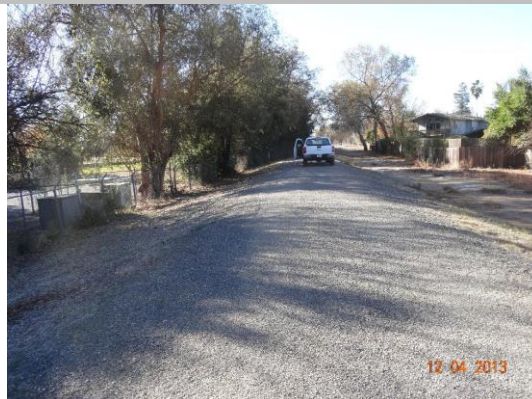
Photo 1 of 3 : UCIP\_SP\_2020\_56453\_47575.jpg

DS\_ID:24477  
FS\_ID:56453  
EP\_NO: 7993  
Repair Type: Non-Urgent  
Crossing Status: Indicator Found  
UCIP Comments: 05/29/2019 Chlorine pipeline appears to be present, according to the yellow markings on the LS fence. Still need test results from PG&E. Crossing is evaluated as Non-Urgent: no maintenance or inspection records available to determine the integrity of the line. (A. McDonald - DWR UCIP)12/04/2013 Unable to confirm if crossing buried is the same as this crossing. (DWR UCIP - O. Magana)  
FIELD\_STRUCT\_DESC: 6-inch plastic lined, IPS Schedule 40, steel chlorine pipeline through the levee, at an unknown depth. Steel cutoff wall around the pipe at the center of the levee. (6-inch line authorized under Permit Nos. 7993 and 7993-A, 1972 - Northeast Sacramento County Sanitation District, Department of Public Works, Water Quality Division).  
FS Date: 5/29/2019

Overview of levee crown looking d/s.

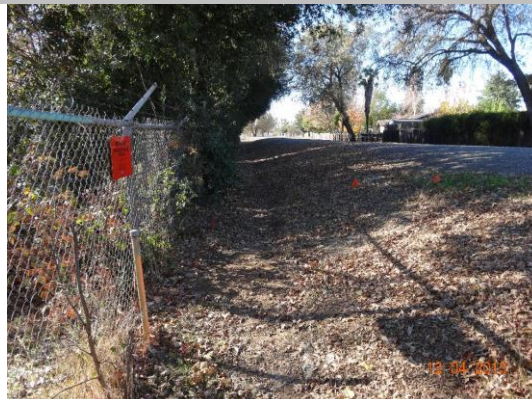
Photo 2 of 3 : UCIP\_SP\_2020\_56453\_47574.jpg

View of WS levee slope looking d/s. Underground Alert System markers showing alignment of chlorine pipe.

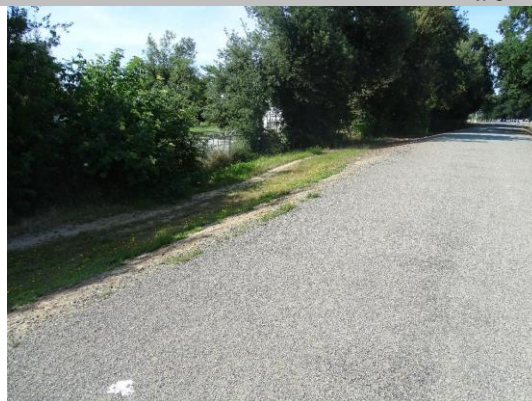
Photo 2 of 3 : UCIP\_SP\_2020\_56454\_79373.jpg

DS\_ID:25448  
FS\_ID:56454  
EP\_NO: 4777-A  
Repair Type: Non-Urgent  
Crossing Status: Indicator Found  
UCIP Comments: 05/29/2019 Natural gas line appears to be present, according to the yellow markings on the LS fence. Still need test results from PG&E. Crossing is evaluated as Non-Urgent: no maintenance or inspection records available for this crossing. (A. McDonald - DWR UCIP)  
FIELD\_STRUCT\_DESC: 1.5-inch polyvinyl chloride (PVC) natural gas service line sleeved through an existing 2.5-inch steel pipe through the levee. Contacts: Sacramento Regional Office, 916-875-9400; Oscar Starks (Supervisor), 916-204-5143; Troy Shurock, 916-599-2413. (2.5-inch steel line authorized under Permit No. 4777, 1964 - Sacramento County Department of Public Works, Water Quality Division. And 1.5-inch PVC line authorized under Permit No. 4777-A, 1974 - Sacramento County Department of Public Works, Water Quality Division).

Overview of WS levee slope looking d/s.

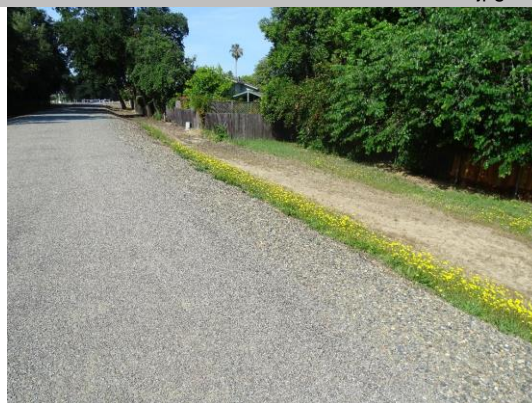
Photo 3 of 3 : UCIP\_SP\_2020\_56454\_79374.jpg

Overview of LS levee slope looking d/s.

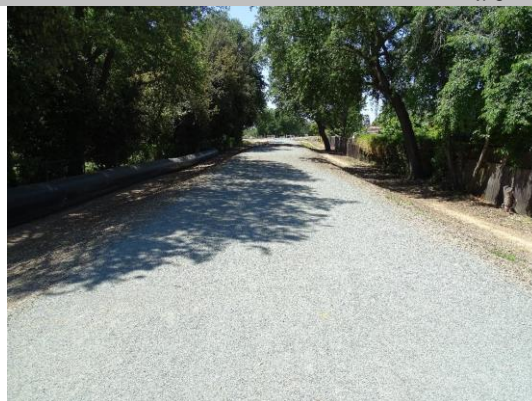
Photo 1 of 3 : UCIP\_SP\_2020\_56801\_84288.jpg

DS\_ID:24418  
FS\_ID:56801  
EP\_NO: 2440  
Repair Type: Non-Urgent  
Crossing Status: Not Found  
UCIP Comments: 05/29/2019 3-inch natural gas pipeline not found during field inspection. Pipeline is evaluated as Non-Urgent because it was not found, and it is a safety issue. Need to contact owner to determine the status of the pipeline. (A. McDonald - DWR UCIP)  
FIELD\_STRUCT\_DESC: 1 of 2: 3-inch concrete encased steel natural gas pipeline through the levee, 8.5 feet below the crown. Concrete cutoff wall around the pipe at the center of the levee. Sealed in an 8-inch casing. (3-inch gas pipeline authorized under Permit No. 2440, 2440-A, and 2440-B, 1957 - Southern Pacific Pipe Lines, Inc.; secondary permits related to this pipeline include Permit No. 7993-A, 1973 - Northeast Sacramento County Sanitation District, Sacramento County Department of Public Works, Water Quality Division).  
FS Date: 5/29/2019

Overview of levee crown looking d/s.

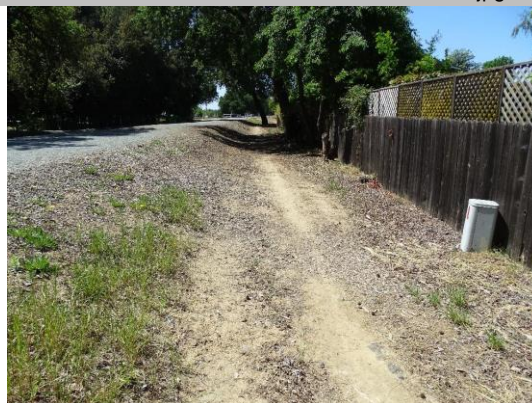
Photo 2 of 3 : UCIP\_SP\_2020\_56801\_84289.jpg

Overview of LS levee slope looking d/s.

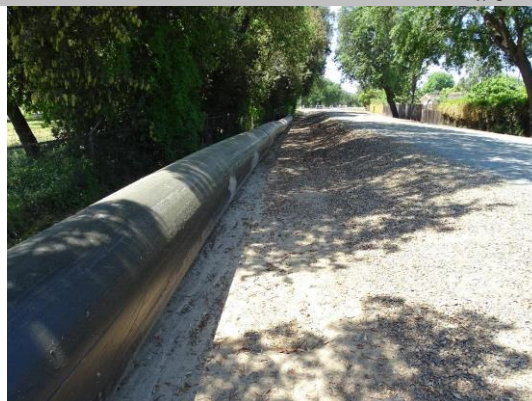
Photo 3 of 3 : UCIP\_SP\_2020\_56801\_84290.jpg

Overview of WS levee slope looking d/s.

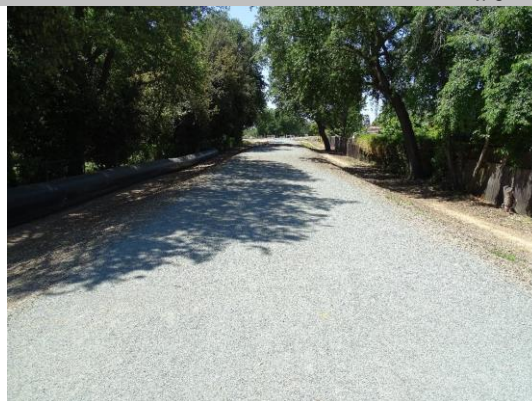
Photo 1 of 3 : UCIP\_SP\_2020\_56802\_84291.jpg

DS\_ID:24100  
FS\_ID:56802  
EP\_NO: 2440  
Repair Type: Non-Urgent  
Crossing Status: Not Found  
UCIP Comments: 05/29/2019 4-inch natural gas pipeline not found during field inspection. Pipeline is evaluated as Non-Urgent because it was not found, and it is a safety issue. Need to contact owner to determine the status of the pipeline. (A. McDonald - DWR UCIP)  
FIELD\_STRUCT\_DESC: 2 of 2: 4-inch concrete encased steel natural gas pipeline through the levee, 8.5 feet below the crown. Concrete cutoff wall around the pipe at the center of the levee. Sealed in an 8-inch casing. (4-inch natural gas pipeline authorized under Permit No. 2440-A, 1957 - Southern Pacific Pipe Lines, Inc.; secondary permits related to this line include Permit No. 7993-A, 1973 - Northeast Sacramento County Sanitation District, Sacramento County Department of Public Works, Water Quality Division). [Additional Reference(s): DWR Levee Log, 2002 (HLM 1.38)]

Overview of levee crown looking d/s.

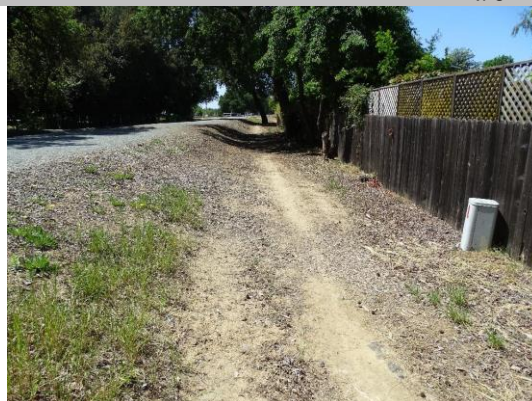
Photo 2 of 3 : UCIP\_SP\_2020\_56802\_84292.jpg

Overview of LS levee slope looking d/s.

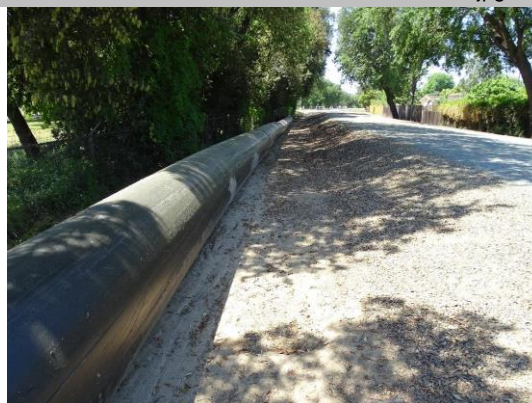
Photo 3 of 3 : UCIP\_SP\_2020\_56802\_84293.jpg

Overview of WS levee slope looking d/s.

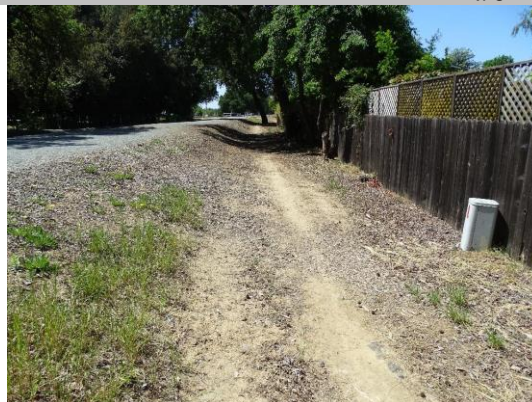
Photo 2 of 3 : UCIP\_SP\_2020\_56803\_84295.jpg

Comment Code						
Inspector Comment						
DS_ID:24099 FS_ID:56803 EP_NO: 2440-B Repair Type: Non-Urgent Crossing Status: Not Found UCIP Comments: 05/29/2019 10-inch petroleum pipeline not found during field inspection. Pipeline is evaluated as Non-Urgent because it was not found, and it is a safety issue. Need to contact owner to determine the status of the pipeline. (A. McDonald - DWR UCIP) FIELD_STRUCT_DESC: 10-inch concrete encased steel petroleum pipeline through the levee, 8.5 feet below the crown. (10-inch petroleum pipeline authorized under Permit No. 2440-B-1957, Southern Pacific Pipe Lines Inc.; secondary permits related to this pipeline include Permit Nos. 7993-A, 2440, and 2440-A). [Additional Reference(s): DWR Levee Log, 2002 (HLM 1.38)] FS Date: 5/29/2019

Overview of LS levee slope looking d/s.

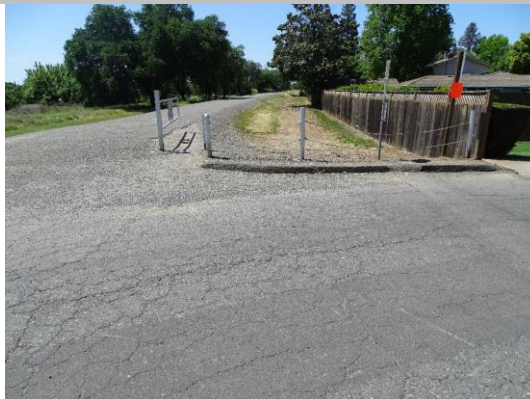
Photo 2 of 3 : UCIP\_SP\_2020\_56804\_84298.jpg

Overview of LS levee slope looking d/s.

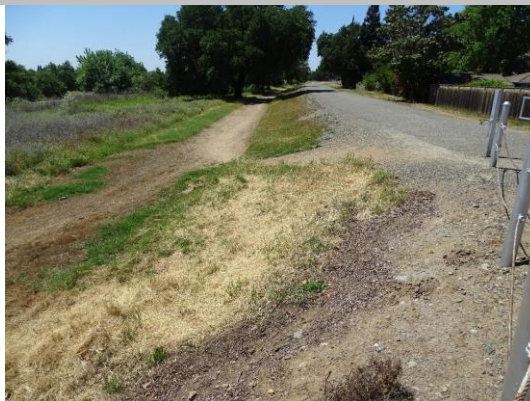
Photo 3 of 3 : UCIP\_SP\_2020\_56804\_84299.jpg

Overview of WS levee slope looking d/s.

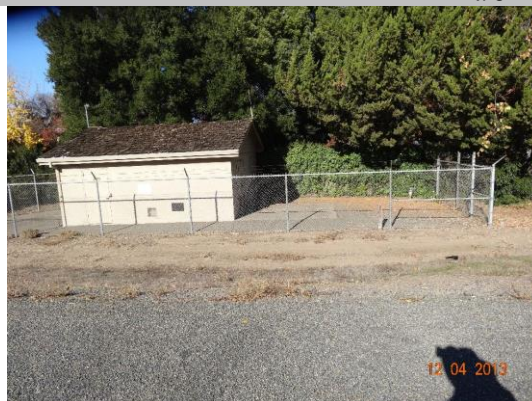
Photo 1 of 3 : UCIP\_SP\_2020\_56463\_54880.jpg

DS\_ID:24419  
FS\_ID:56463  
EP\_NO: N/A  
Repair Type: Non-Urgent  
Crossing Status: Found  
UCIP Comments: 05/29/2019 A valve was added since the last inspection. This crossing is in use. This crossing is evaluated as Non-Urgent because it is an unauthorized encroachment. We cannot find a permit for this crossing. (A. McDonald - DWR UCIP)12/04/2013 Need to find out the status of this crossing. Unable to determine if crossing is being used. (O. Magana - DWR UCIP)  
FIELD\_STRUCT\_DESC: 24-inch pipe of an unknown material or purpose through the levee, 7 feet below the crown. Concrete inspection box at the waterside (WS) toe. Structure located on the landside (LS). Chlorine line and valve markers on the LS between the structure and the levee toe. Water line access cover on the LS near the levee toe. Valve encased in a green steel box on the LS shoulder.  
FS Date: 5/29/2019

Structure located on the LS.

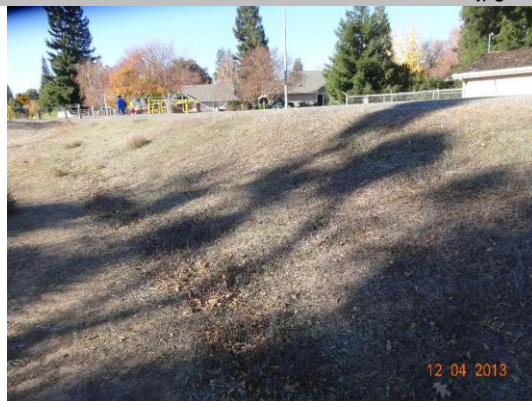
Photo 2 of 3 : UCIP\_SP\_2020\_56463\_54881.jpg

Overview of WS levee slope looking d/s.

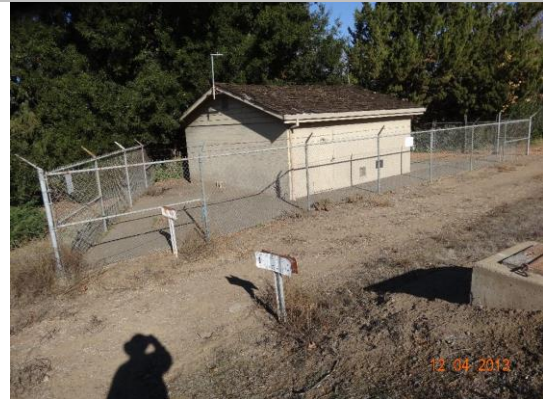
Photo 2 of 3 : UCIP\_SP\_2020\_56464\_57289.jpg

DS\_ID:24101  
FS\_ID:56464  
EP\_NO: N/A  
Repair Type: Non-Urgent  
Crossing Status: Found  
UCIP Comments: 05/29/2019 A valve was added since the last inspection. This crossing is in use. This crossing is evaluated as Non-Urgent because it is an unauthorized encroachment. We cannot find a permit for this crossing. There has also been an unauthorized modification to this crossing. Need to determine owner. (A. McDonald - DWR UCIP)12/04/2013 Need to determine the status of this crossing. Unable to determine if crossing is still active. (O. Magana - DWR UCIP) FIELD\_STRUCT\_DESC: 8-inch pipe of an unknown material or purpose through the levee at an unknown depth. Concrete inspection box on the landside (LS) slope. [Additional Reference(s): DWR Levee Log, 2002 (HLM 1.63)]  
FS Date: 5/29/2019

View of LS. Chlorine line adjacent to 8-inch pipe.

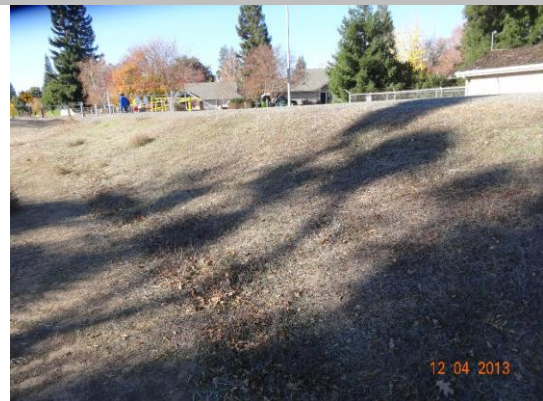
Photo 3 of 3 : UCIP\_SP\_2020\_56464\_57291.jpg

Overview of WS levee slope looking d/s.

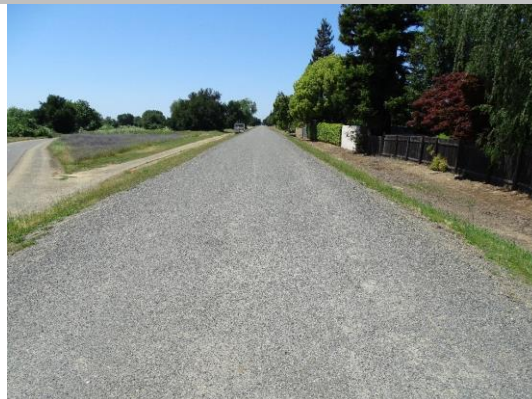
Photo 1 of 3 : UCIP\_SP\_2020\_56806\_84303.jpg

Comment Code						
Inspector Comment						
DS_ID:24474 FS_ID:56806 EP_NO: 5364 Repair Type: Non-Urgent Crossing Status: Not Found UCIP Comments: 05/29/2019 No evidence of water main as described in Permit Nos. 5364 and 5364-A. Crossing has been evaluated as Non-Urgent because permit records indicate a crossing was constructed; however, there is no evidence of a pipe. Unable to determine if crossing still exists. (A. McDonald - DWR UCIP) FIELD_STRUCT_DESC: 24-inch steel water main through the levee, 3 feet below the crown, not found in 2019. Concrete cutoff wall around the pipe at the center of the levee, not found in 2019. Diversion structure on the waterside (WS), not found in 2019. (24-inch steel water main authorized under Permit No. 5364, 1966 - Arcade County Water District [ACWD]; amended under secondary Permit No. 5364-A, 1966 - ACWD). FS Date: 5/29/2019

Overview of levee crown looking d/s.

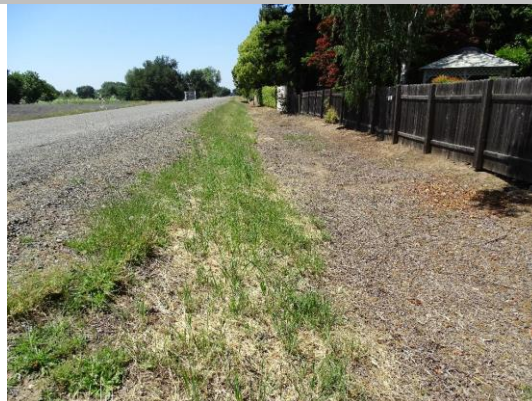
Photo 2 of 3 : UCIP\_SP\_2020\_56806\_84304.jpg

Overview of LS levee slope looking d/s.

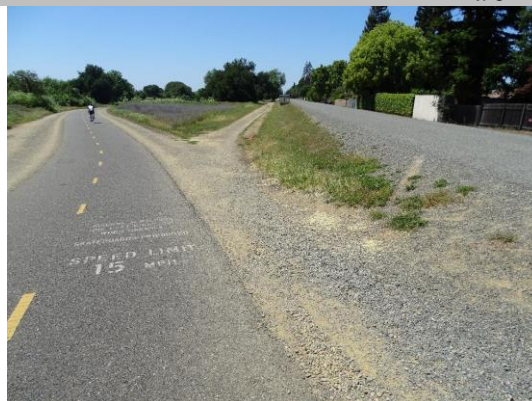
Photo 3 of 3 : UCIP\_SP\_2020\_56806\_84305.jpg

Overview of WS levee slope looking d/s.

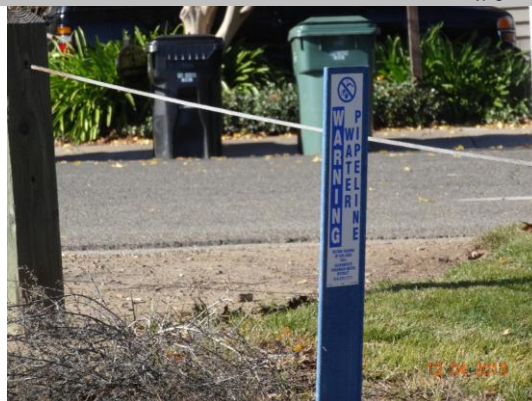
Photo 1 of 3 : UCIP\_SP\_2020\_56468\_56338.jpg

DS\_ID:24822  
FS\_ID:56468  
EP\_NO: N/A  
Repair Type: Non-Urgent  
Crossing Status: Indicator Found  
UCIP Comments: 05/29/2019 Blue marker on the LS levee toe indicating there is an underground drinking water pipeline. Crossing is evaluated as Non-Urgent: This is an unauthorized encroachment because there is no permit available authorizing the installation. (A. McDonald - DWR UCIP)12/04/2013 Second marker visible on the LS at levee mile 1.63 (38.581564, -121.343806). (O. Magana - DWR UCIP) FIELD\_STRUCT\_DESC: Drinking water pipeline of an unknown size or material, at an unknown depth. Blue water line marker located on the landside (LS) levee toe. Unable to determine if the line runs parallel to the levee or if the line crosses the levee. Unable to find encroachment permit authorizing the installation of this pipe.  
FS Date: 5/29/2019

Drinking water pipeline marker on LS levee toe at levee mile 1.63.

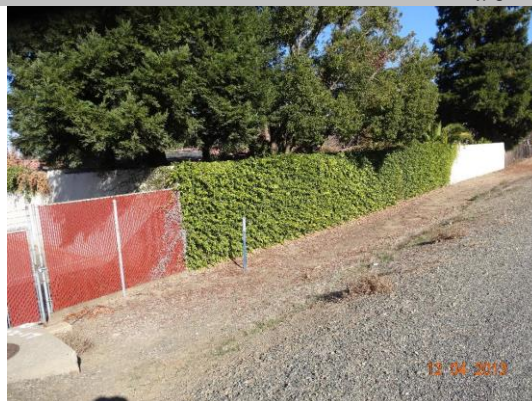
Photo 2 of 3 : UCIP\_SP\_2020\_56468\_56337.jpg

Drinking water pipeline marker on LS levee toe at levee mile 1.63.

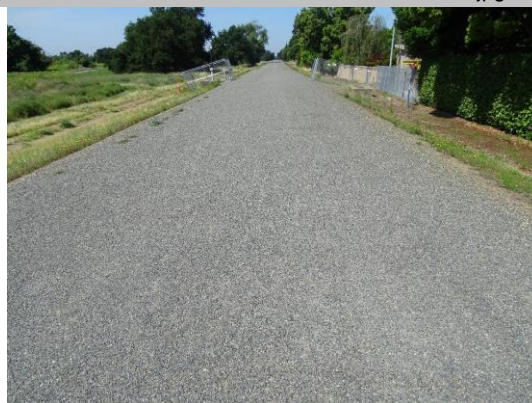
Photo 3 of 3 : UCIP\_SP\_2020\_56468\_79448.jpg

Overview of levee crown looking d/s.

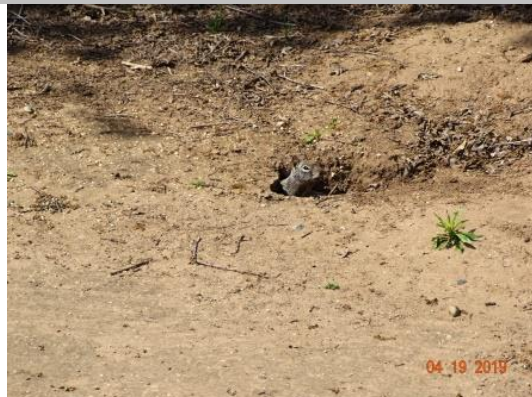
Photo 1 of 1 : SP\_2020\_NA0001\_61\_36\_20200302\_00012.jpg

LM Start	2.07	Rating **	M	Issue No.	36
LM End	2.07	Issue Type +	Ma	Location *	LS
Category	Earthen Levee			GPS Latitude/Longitude	
				Start	End
Item	Animal Control			38.577573 °	38.577573 °
				-121.352332 °	-121.352332 °
DWR ID	DWR_NA0001_10_s_2019_36				
Comment Code					
A1 : Exterminate rodents and backfill and compact or grout burrows.					
Inspector Comment

View of squirrel hole with activity along toe road. Spring 2019

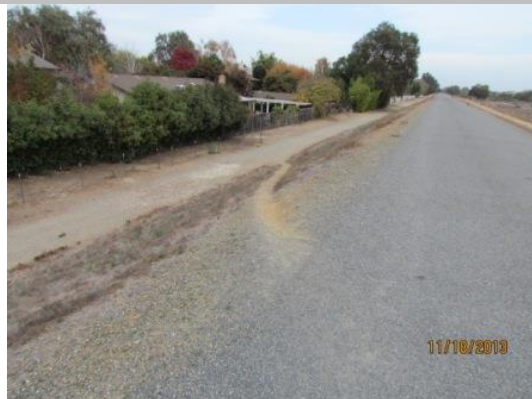
Photo 1 of 1 : SP\_2020\_NA0001\_61\_7\_20200302\_00002.jpg

LM Start	2.41	Rating **	A/W	Issue No.	7
LM End	2.41	Issue Type +	Ma	Location *	LS
Category	Earthen Levee			GPS Latitude/Longitude	
				Start	End
Item	Slope Stability			38.575126 °	38.575126 °
				-121.357575 °	-121.357575 °
DWR ID	DWR_NA0001_10_f_2013_7				
Comment Code					
S2 : Repair the levee slope damaged by foot traffic and prevent access where possible.					
Inspector Comment

View of the pathway on the landside levee slope. Fall 2013

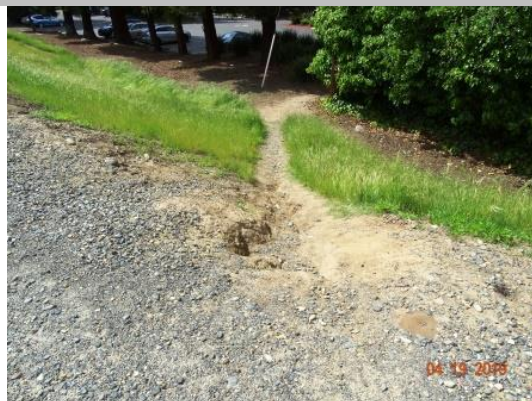
Photo 1 of 1 : SP\_2020\_NA0001\_61\_19\_20200302\_00004.jpg

LM Start	3.48	Rating **	M	Issue No.	19
LM End	3.48	Issue Type +	Ma	Location *	LS
Category	Earthen Levee			GPS Latitude/Longitude	
				Start	End
Item	Slope Stability			38.569494 °	38.569494 °
				-121.375684 °	-121.375684 °
DWR ID	DWR_NA0001_10_f_2018_19				
Comment Code					
S2 : Repair the levee slope damaged by foot traffic and prevent access where possible.					
Inspector Comment

View of footpath on landside slope. Spring 2019

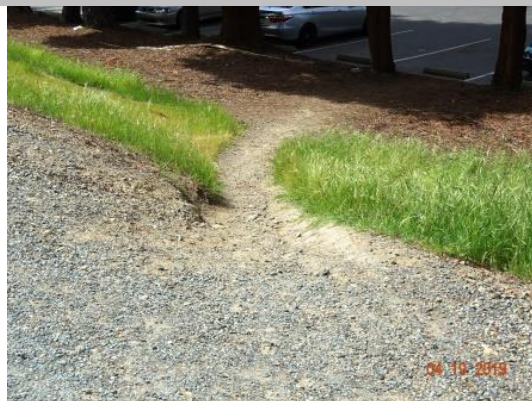
Photo 1 of 1 : SP\_2020\_NA0001\_61\_21\_20200302\_00005.jpg

LM Start	3.49	Rating **	M	Issue No.	21
LM End	3.49	Issue Type +	Ma	Location *	LS
Category	Earthen Levee			GPS Latitude/Longitude	
				Start	End
Item	Slope Stability			38.569484 °	38.569484 °
				-121.375841 °	-121.375841 °
DWR ID	DWR_NA0001_10_f_2015_21				
Comment Code					
S2 : Repair the levee slope damaged by foot traffic and prevent access where possible.					
Inspector Comment

View of footpath on landside slope. Spring 2019

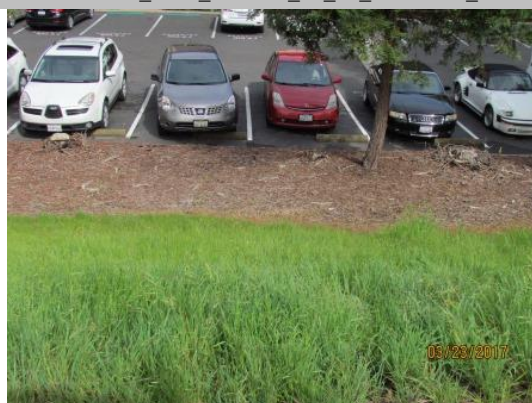
Photo 1 of 1 : SP\_2020\_NA0001\_61\_29\_20200302\_00010.jpg

LM Start	3.56	Rating **	N	Issue No.	29
LM End	3.56	Issue Type +	Ma	Location *	LS
Category	Earthen Levee			GPS Latitude/Longitude	
				Start	End
Item	Trim / Thin Trees			38.569242 °	38.569242 °
				-121.377169 °	-121.377169 °
DWR ID	DWR_NA0001_10_s_2017_29				
Comment Code					
T5 : Tree stumps.					
Inspector Comment					
Three tree stumps are within the levee easement.

View of the tree stumps within the levee easement. Spring 2017

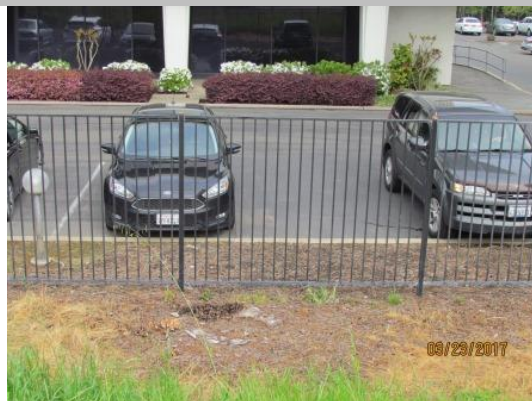
Photo 1 of 1 : SP\_2020\_NA0001\_61\_28\_20200302\_00009.jpg

LM Start	3.77	Rating **	N	Issue No.	28
LM End	3.77	Issue Type +	Ma	Location *	LS
Category	Earthen Levee			GPS Latitude/Longitude	
				Start	End
Item	Trim / Thin Trees			38.568375 °	38.568375 °
				-121.380889 °	-121.380889 °
DWR ID	DWR_NA0001_10_s_2017_28				
Comment Code					
T5 : Tree stumps.					
Inspector Comment

View of the tree stump at the levee toe. Spring 2017

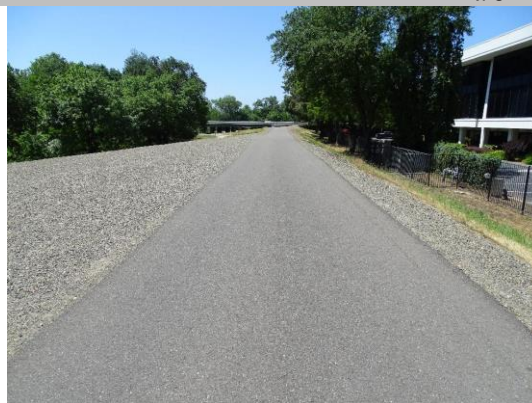
Photo 1 of 3 : UCIP\_SP\_2020\_56807\_84306.jpg

LM Start	3.79	Rating **	M	Issue No.	65
LM End	3.79	Issue Type +	En	Location *	
Category	Supplemental			GPS Latitude/Longitude	
				Start	End
Item	DWR UCIP Field Study			38.568265 °	38.568265 °
				-121.381196 °	-121.381196 °
DWR ID	24518				
Comment Code					
Inspector Comment					
DS_ID:24518 FS_ID:56807 EP_NO: N/A Repair Type: Non-Urgent Crossing Status: Not Found UCIP Comments: 05/29/2019 Crossing evaluated as Non-Urgent: pipe not found; unauthorized encroachment; USACE O&M legacy system pipe. (A. McDonald - DWR UCIP) FIELD_STRUCT_DESC: 10-inch pipe of an unknown material or purpose through the levee at an unknown depth, not found in 2019. [Additional Reference(s): USACE Sacramento O&M Manual Unit 517, Part No. 1, November 1959, Drawing No. 1-4-415, Sheet No. 415/5, February 1957, (Station 224+30)] FS Date: 5/29/2019

Overview of levee crown looking d/s.

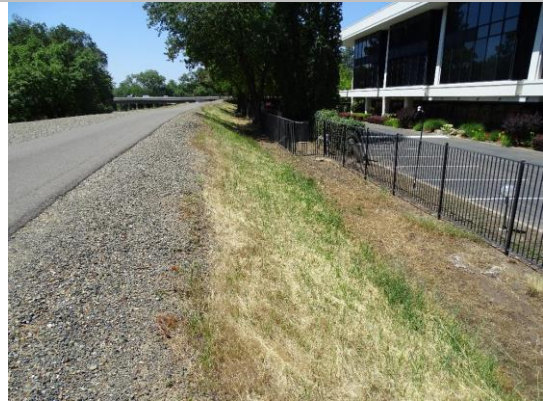
Photo 2 of 3 : UCIP\_SP\_2020\_56807\_84307.jpg

Overview of LS levee slope looking d/s.

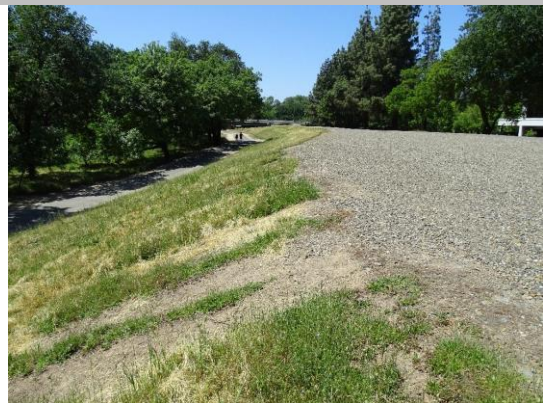
Photo 3 of 3 : UCIP\_SP\_2020\_56807\_84308.jpg

Overview of WS levee slope looking d/s.

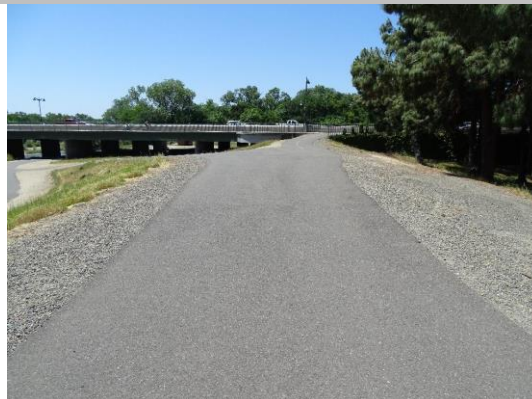
Photo 1 of 3 : UCIP\_SP\_2020\_56808\_84309.jpg

LM Start	3.88	Rating **	M	Issue No.	66	
LM End	3.88	Issue Type +	En	Location *		
Category	Supplemental			GPS Latitude/Longitude		
				Start	End	
Item	DWR UCIP Field Study			38.567947 °	38.567947 °	
				-121.382770 °	-121.382770 °	
DWR ID	24414					
Comment Code						
Inspector Comment						
DS_ID:24414						
FS_ID:56808						
EP_NO: N/A						
Repair Type: Non-Urgent						
Crossing Status: Not Found						
UCIP Comments: 05/29/2019 Crossing evaluated as Non-Urgent: pipe not found; unauthorized encroachment. (A. McDonald - DWR UCIP)						
FIELD_STRUCT_DESC: 24-inch pipe of an unknown material or purpose through the levee at an unknown depth, not found in 2019. 36-inch riser located on the waterside (WS) slope, not found in 2019.						
[Additional Reference(s): DWR Levee Log, 2002 (HLM 4.01)]						
FS Date: 5/29/2019

Overview of levee crown looking d/s. Watt Avenue Bridge in the background.

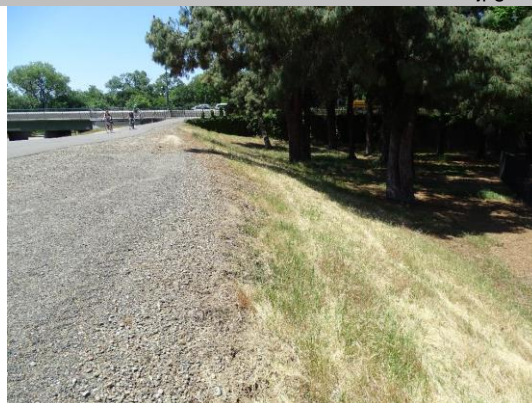
Photo 2 of 3 : UCIP\_SP\_2020\_56808\_84310.jpg

Overview of LS levee slope looking d/s. Watt Avenue Bridge in the background.

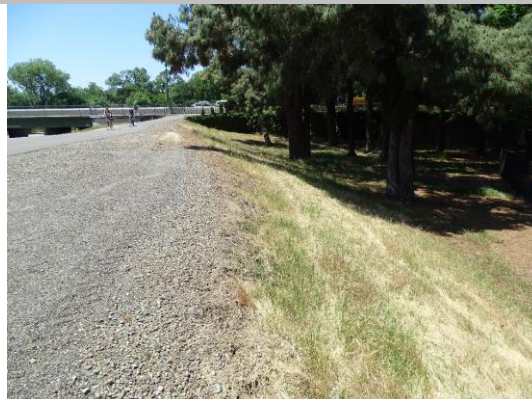
Photo 2 of 3 : UCIP\_SP\_2020\_56809\_84313.jpg

Overview of LS levee slope looking d/s. Watt Avenue Bridge in the background.

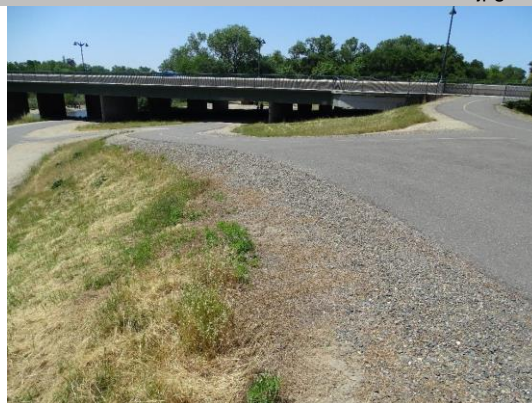
Photo 3 of 3 : UCIP\_SP\_2020\_56809\_84314.jpg

Overview of WS levee slope looking d/s. Watt Avenue Bridge in the background.

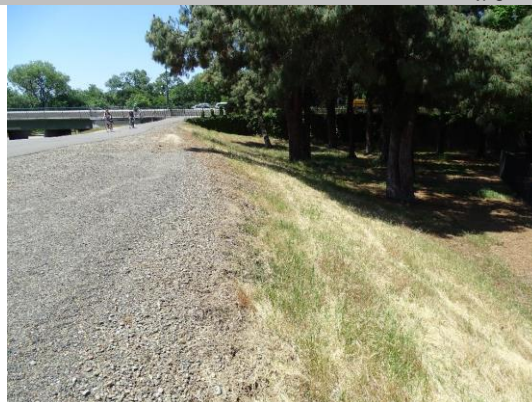
Photo 2 of 3 : UCIP\_SP\_2020\_56810\_84317.jpg

Comment Code						
Inspector Comment						
DS_ID:24416 FS_ID:56810 EP_NO: 5997 Repair Type: Non-Urgent Crossing Status: Not Found UCIP Comments: 05/29/2019 Crossing evaluated as Non-Urgent: Permit indicates crossing was constructed; however, it was not found during field inspection. (A. McDonald - DWR UCIP) FIELD_STRUCT_DESC: Two 5-inch concrete encased steel electrical conduits through the levee, 2.5 feet below the crown, not found in 2019. Concrete manholes under overhanging sidewalk against the bridge abutments on the crown, not found in 2019. (Two electrical conduits authorized under Permit No. 5997, 1968 - Sacramento Municipal Utility District [SMUD]). [Additional Reference(s): DWR Levee Log, 2002 (HLM 4.01)] FS Date: 5/29/2019

Overview of LS levee slope looking d/s. Watt Avenue Bridge in the background.

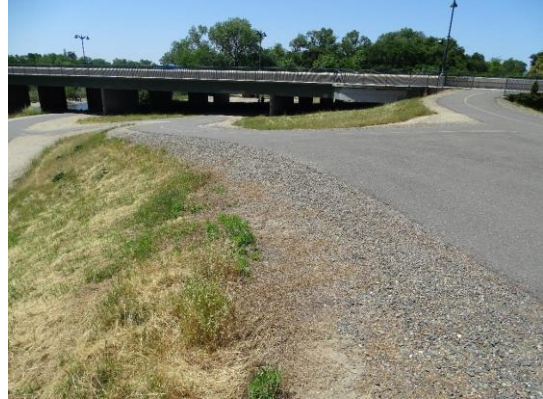
Photo 3 of 3 : UCIP\_SP\_2020\_56810\_84318.jpg

Overview of WS levee slope looking d/s. Watt Avenue Bridge in the background.

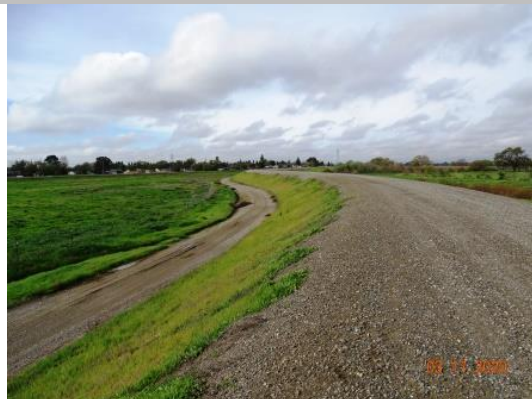
Photo 1 of 1 : SP\_2020\_NA0001\_436\_6\_20200319\_00013.jpg

LM Start	0.00	Rating **	A	Issue No.	6
LM End	0.46	Issue Type +	Ma	Location *	LS
Category	Earthen Levee			GPS Latitude/Longitude	
				Start	End
Item	Vegetation			38.662445 °	38.666527 °
				-121.457867 °	-121.451362 °
DWR ID	DWR_NA0001_11_s_2020_6				
Comment Code					
V1 : Control annual grass and weeds on the levee slopes and easements.					
Inspector Comment

View of well-maintained landside vegetation. Spring 2020

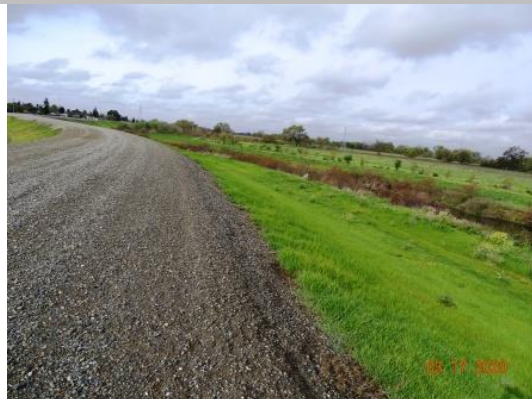
Photo 1 of 1 : SP\_2020\_NA0001\_436\_7\_20200319\_00014.jpg

LM Start	0.00	Rating **	A	Issue No.	7
LM End	0.46	Issue Type +	Ma	Location *	WS
Category	Earthen Levee			GPS Latitude/Longitude	
				Start	End
Item	Vegetation			38.662443 °	38.666527 °
				-121.457867 °	-121.451362 °
DWR ID	DWR_NA0001_11_s_2020_7				
Comment Code					
V1 : Control annual grass and weeds on the levee slopes and easements.					
Inspector Comment

View of well-maintained waterside vegetation. Spring 2020

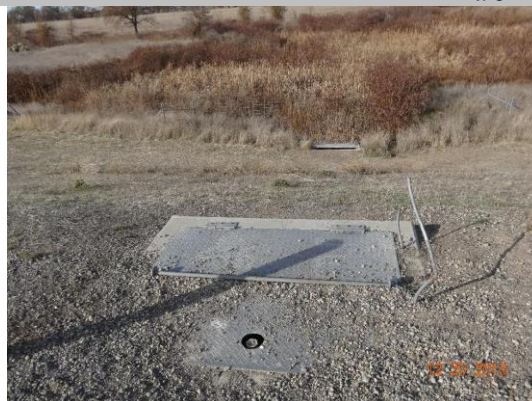
Photo 1 of 3 : UCIP\_SP\_2020\_31310\_57345.jpg

Comment Code					
Inspector Comment					
DS_ID:24823 FS_ID:31310 EP_NO: N/A Repair Type: Non-Urgent Crossing Status: Found UCIP Comments: 08/16/2017 DWR Deferred Maintenance Project (DMP), Vince Rodriguez, forwarded email received from Tim Kerr, General Manager of American River Flood Control District (ARFCD) with file "DWR Eligible Pipes Found in ARFCD" from ARFCD that shows the ownership and location of the pipes Tim Kerr investigated. Owner of this crossing is identified as the City of Sacramento, ARFCD Staff Notes indicate Claire Ave. (DWR UCIP - O. Magana) 12/20/2013 no permit found--owner? (unauthorized?) (DWR UCIP - O. Magana) FIELD_STRUCT_DESC: 24-inch pipe through the levee at unknown depth. Concrete box located on waterside (WS) shoulder. Concrete wall located on waterside (WS) and landside (LS). Siphon breaker inside concrete service box located on WS shoulder. (no permit has been identified authorizing this structure, structure is owned by the City of Sacramento) FS Date: 12/20/2013

View of waterward side.

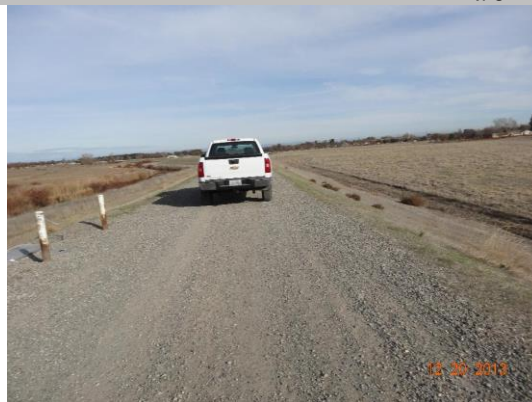
Photo 2 of 3 : UCIP\_SP\_2020\_31310\_57342.jpg

View of levee crown at crossing.

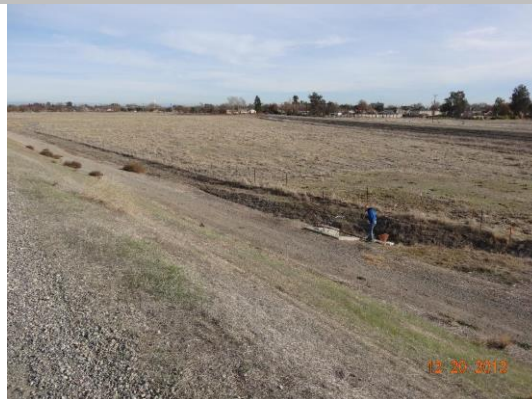
Photo 3 of 3 : UCIP\_SP\_2020\_31310\_57343.jpg

View of landward side.

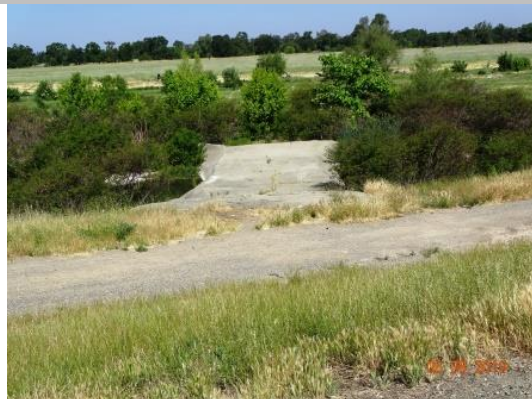
Photo 1 of 2 : SP\_2020\_NA0001\_436\_10\_20200302\_00003.jpg

LM Start	0.35	Rating **	M	Issue No.	10
LM End	0.35	Issue Type +	En	Location *	WS
Category	Earthen Levee			GPS Latitude/Longitude	
				Start	End
Item	Encroachments			38.665052 °	38.665052 °
				-121.452505 °	-121.452505 °
DWR ID	DWR_NA0001_11_s_2019_10				
Comment Code					
RA : Ramp					
Inspector Comment					
According to the LMA, SAFCA placed a concrete cow ramp over the creek, but the ramp does not seem to be associated with a permit.

View looking north at concrete ramp over creek. Spring 2019

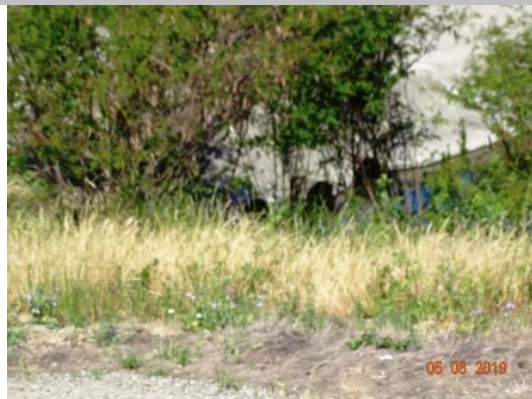
Photo 2 of 2 : SP\_2020\_NA0001\_436\_10\_20200302\_00004.jpg

View looking north at culverts built into ramp. Spring 2019

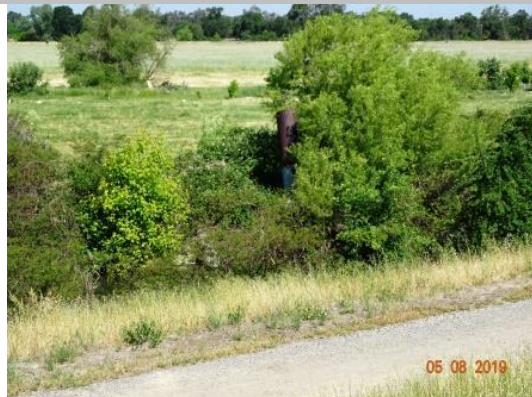
Photo 1 of 1 : SP\_2020\_NA0001\_436\_8\_20200302\_00002.jpg

LM Start	0.37	Rating **	M	Issue No.	8
LM End	0.37	Issue Type +	En	Location *	WS
Category	Earthen Levee			GPS Latitude/Longitude	
				Start	End
Item	Encroachments			38.665335 °	38.665335 °
				-121.452328 °	-121.452328 °
DWR ID	DWR_NA0001_11_s_2019_8				
Comment Code					
PI : Pipe					
Inspector Comment					
A metal standpipe within the creek does not appear to be authorized.

View looking north at a metal standpipe within the creek. Spring 2019

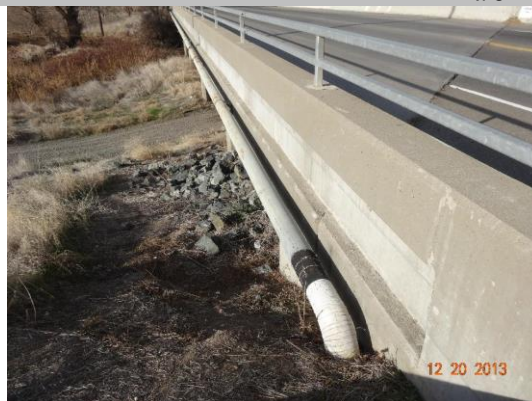
Photo 1 of 1 : UCIP\_SP\_2020\_31311\_57346.jpg

LM Start	0.48	Rating **	M	Issue No.	12
LM End	0.48	Issue Type +	En	Location *	
Category	Supplemental			GPS Latitude/Longitude	
				Start	End
Item	DWR UCIP Field Study			38.666585 °	38.666585 °
				-121.451009 °	-121.451009 °
DWR ID	24824				
Comment Code					
Inspector Comment					
DS_ID:24824 FS_ID:31311 EP_NO: N/A Repair Type: Non-Urgent Crossing Status: Found UCIP Comments: owner? permit? (unauthorized?) FIELD_STRUCT_DESC: 6-inch conduit through levee at unknown depth. Conduit extends across the channel, attached to bridge. FS Date: 12/20/2013

Crossing visible on waterward side.

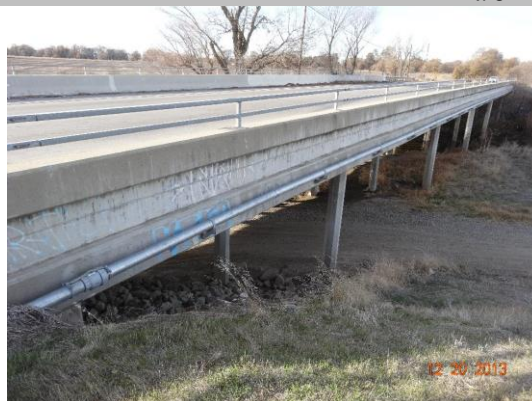
Photo 1 of 1 : UCIP\_SP\_2020\_31312\_57347.jpg

LM Start	0.49	Rating **	M	Issue No.	13
LM End	0.49	Issue Type +	En	Location *	
Category	Supplemental			GPS Latitude/Longitude	
				Start	End
Item	DWR UCIP Field Study			38.666745 °	38.666745 °
				-121.450918 °	-121.450918 °
DWR ID	24825				
Comment Code					
Inspector Comment					
DS_ID:24825 FS_ID:31312 EP_NO: N/A Repair Type: Non-Urgent Crossing Status: Found UCIP Comments: owner? permit? (unauthorized?) FIELD_STRUCT_DESC: 4-inch communication conduit of unknown material through levee at unknown depth. Conduit extends across the channel, attached to bridge. FS Date: 12/20/2013

Conduit attached to the upstream face of Rio Linda Blvd Bridge.

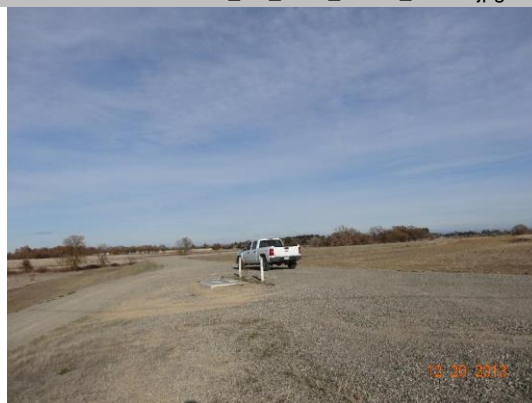
Photo 1 of 3 : UCIP\_SP\_2020\_31313\_57349.jpg

Comment Code						
Inspector Comment						
DS_ID:24826 FS_ID:31313 EP_NO: N/A Repair Type: Non-Urgent Crossing Status: Found UCIP Comments: 08/16/2017 DWR Deferred Maintenance Project (DMP), Vince Rodriguez, forwarded email received from Tim Kerr, General Manager of American River Flood Control District (ARFCD) with file "DWR Eligible Pipes Found in ARFCD" from ARFCD that shows the ownership and location of the pipes Tim Kerr investigated. Owner of this crossing is identified as the City of Sacramento, ARFCD Staff Notes indicate Rio Linda, just Upstream. (DWR UCIP - O. Magana) 12/20/2013 owner? permit? (unauthorized?) (DWR UCIP - O. Magana) FIELD_STRUCT_DESC: 24-inch (estimate only field verify) storm drain pipe through levee at an unknown depth. Concrete headwalls with debris screens located on waterside (WS) and landside (LS). Concrete box with protective posts located on WS shoulder. (no permit has been identified authorizing this structure, structure is owned by the City of Sacramento) FS Date: 12/20/2013

View of levee crown at crossing.

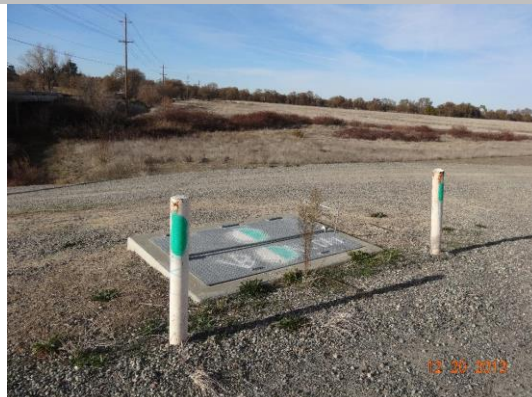
Photo 2 of 3 : UCIP\_SP\_2020\_31313\_57348.jpg

Concrete vault with protective posts located on waterward shoulder.

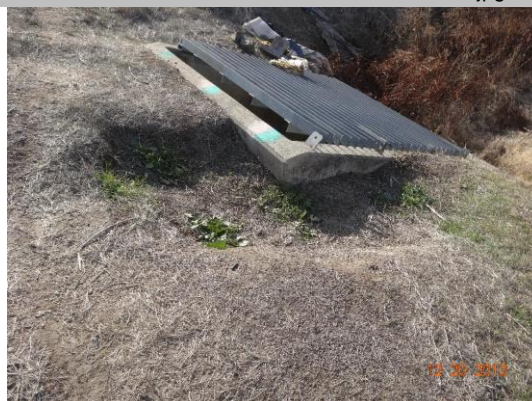
Photo 3 of 3 : UCIP\_SP\_2020\_31313\_57351.jpg

Concrete headwall located on waterward side--depression found on wall edge.

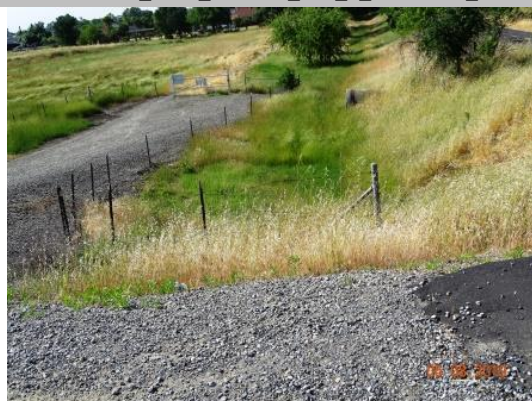
Photo 1 of 1 : SP\_2020\_NA0001\_436\_5\_20200302\_00001.jpg

LM Start	0.73	Rating **	M	Issue No.	5
LM End	0.73	Issue Type +	En	Location *	LS
Category	Earthen Levee			GPS Latitude/Longitude	
				Start	End
Item	Encroachments			38.667978 °	38.667978 °
				-121.447438 °	-121.447438 °
DWR ID	DWR_NA0001_11_s_2019_5				
Comment Code					
FE : Fence					
Inspector Comment

View looking southward at barbed wire fence at levee toe. Spring 2019

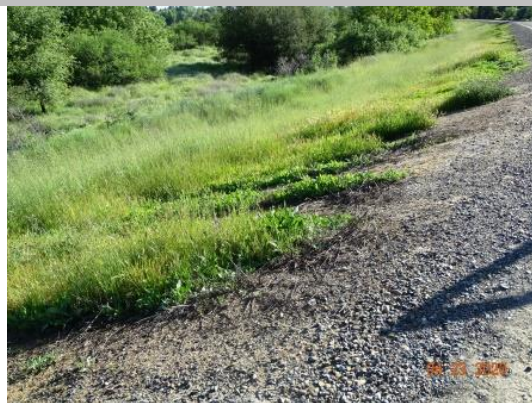
Photo 1 of 1 : SP\_2020\_NA0001\_438\_21\_20200508\_00016.jpg

LM Start	0.10	Rating **	M	Issue No.	21
LM End	0.33	Issue Type +	Ma	Location *	WS
Category	Earthen Levee			GPS Latitude/Longitude	
				Start	End
Item	Vegetation			38.571250 °	38.573280 °
				-121.353200 °	-121.349848 °
DWR ID	DWR_NA0001_12_s_2020_21				
Comment Code					
V1 : Control annual grass and weeds on the levee slopes and easements.					
Inspector Comment

View of waterside vegetation. Spring 2020

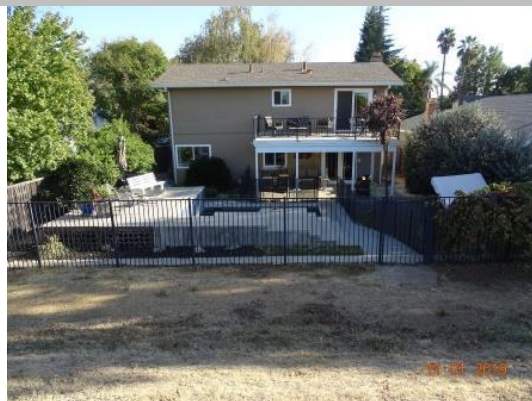
Photo 1 of 1 : SP\_2020\_NA0001\_438\_25\_20200302\_00006.jpg

LM Start	0.13	Rating **	M	Issue No.	25
LM End	0.13	Issue Type +	En	Location *	LS
Category	Earthen Levee			GPS Latitude/Longitude	
				Start	End
Item	Encroachments			38.571443 °	38.571443 °
				-121.352712 °	-121.352712 °
DWR ID	DWR_NA0001_12_f_2019_25				
Comment Code					
PL : Pool					
Inspector Comment					
A pool within 100' of the levee toe appears to be unauthorized.

View of a pool within 100' of the levee toe. Fall 2019

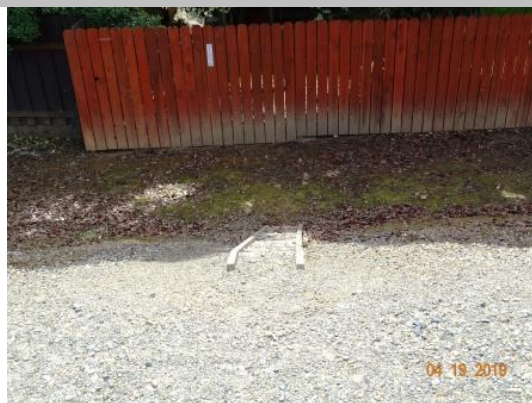
Photo 1 of 1 : SP\_2020\_NA0001\_438\_15\_20200302\_00005.jpg

LM Start	0.28	Rating **	M	Issue No.	15
LM End	0.28	Issue Type +	En	Location *	LS
Category	Earthen Levee			GPS Latitude/Longitude	
				Start	End
Item	Encroachments			38.572765 °	38.572765 °
				-121.350565 °	-121.350565 °
DWR ID	DWR_NA0001_12_s_2019_15				
Comment Code					
ST : Stairway					
Inspector Comment					
Landowner installed a wooden stairway on the levee slope.

View looking south at wooden stairs built into levee slope. Spring 2019

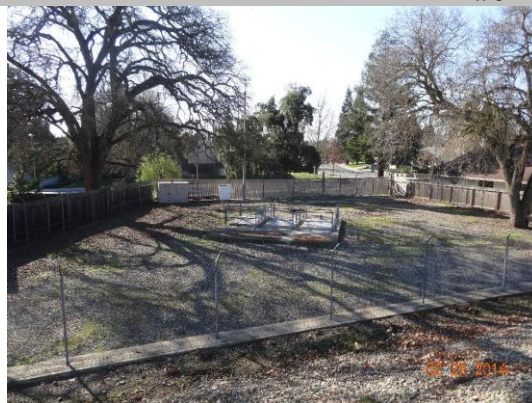
Photo 1 of 3 : UCIP\_SP\_2020\_46995\_56234.jpg

Comment Code					
Inspector Comment					
DS_ID:24830					
FS_ID:46995					
EP_NO: N/A					
Repair Type: Non-Urgent					
Crossing Status: Indicator Found					
UCIP Comments: Unable to confirm pipe size--need to contact owner to obtain additional information on crossing.					
FIELD_STRUCT_DESC: [SRCSD Facility N16 NE Siphon Outlet] 1 of 3: 48-inch reinforced concrete (RC) drainage pipe through the levee, 11 feet below crown. Pipe crosses levee at an angle. Sacramento Regional County Sanitation District (SRCSD) Facility N16 NE Siphon Outlet located on landside (LS). Facility is fenced off. Inside facility are 3 concrete boxes with 3 manholes. (three 48-inch pipes authorized under Permit No. 12144, 1978-SRCSD; cathodic protection for 48-inch pipe authorized under 12144-A, 1983-SRCSD)					
FS Date: 2/25/2014

Concrete vault located on landward side.

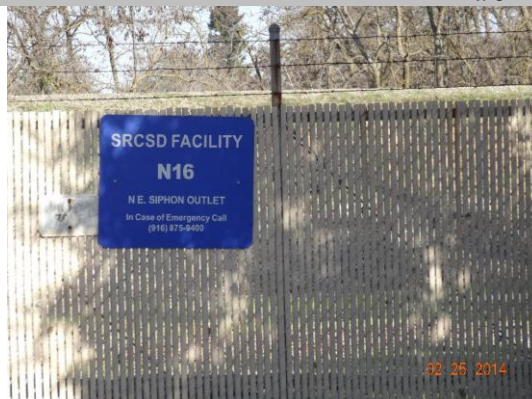
Photo 2 of 3 : UCIP\_SP\_2020\_46995\_56235.jpg

SRCSD Facility N16, NE Siphon Outlet, sign visible from Mira Del Rio Drive.

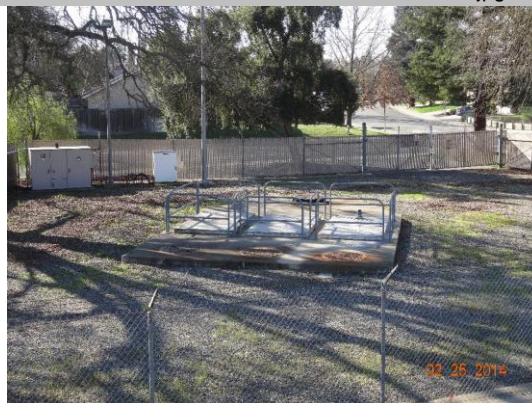
Photo 3 of 3 : UCIP\_SP\_2020\_46995\_56233.jpg

Manholes located on landward side.

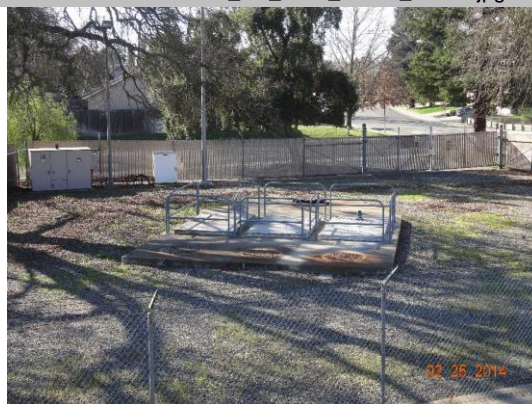
Photo 2 of 3 : UCIP\_SP\_2020\_30540\_56230.jpg

Manholes visible on landward side.
